Annual Inspection Report

Folsom Field

ANNUAL INSPECTION REPORT

FOLSOM FIELD CULLMAN, ALABAMA

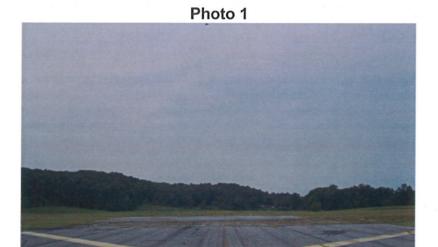
- → Runway 2 The approach to Runway 2 is unobstructed and meets licensing requirements.
- → Violation Runway 20 The approach to Runway 20 is obstructed by a line of trees. The trees are located approximately 400 feet from the runway end and extend from the centerline west across the approach. The trees reduce the required 20:1 slope to 17:1.

Approach to Runway 2

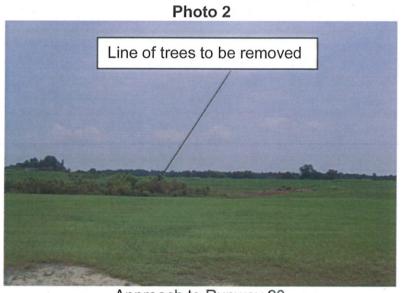
Approach to Runway 20

→ The trees must be removed to meet licensing requirements. The entire line of trees should be removed from within airport property and the area maintained in mowable condition.

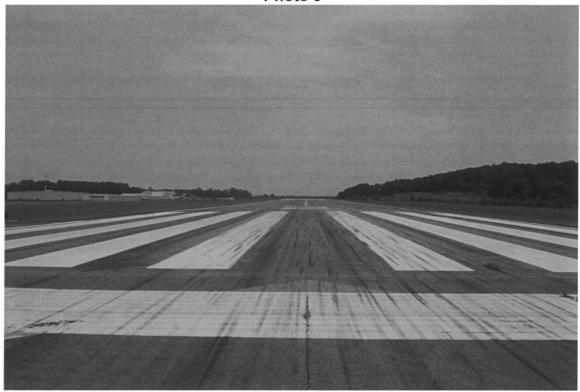
→ The airport markings are in GOOD condition.

Runway Identifier markings of Runway 2

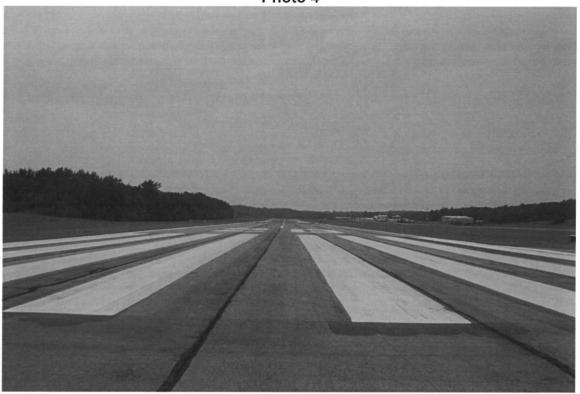
Runway Identifier markings of Runway 20

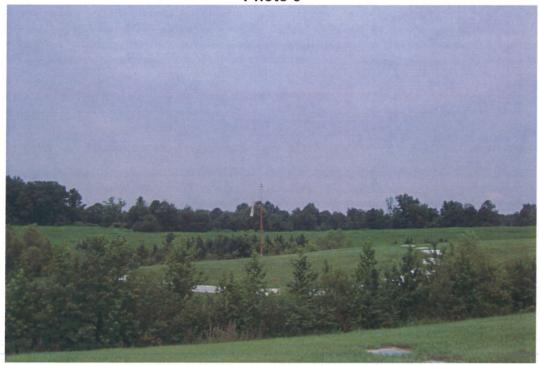
→ The wind direction indicator (windsock) was inspected and found to be operational.

Windsock and segmented circle

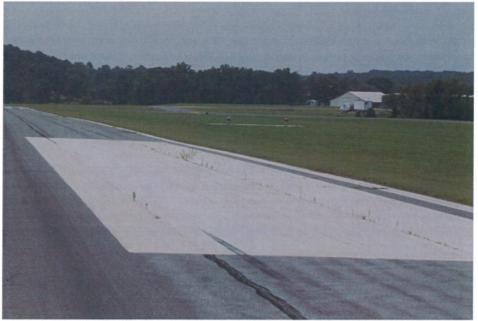
Vegetation in cracks within the aiming bars

- → Vegetation should be eradicated and the cracks cleaned and sealed from the runway within the aiming bars.
- → There are two areas in the taxiway to Runway 2 that have an alligator crack condition. This condition is indicative of imminent pavement failure.
- → The area where the center taxi connector to the runway intersects the taxiways and apron has a large area of failed pavement.
- → The taxiway to Runway 20 has an area of pavement over a drainage structure that is uneven and has loose aggregate.
- → The taxiway to Runway 20 has a 3 foot wide area along the west edge of the taxiway 300 to 330 feet from the north taxi connector that has deteriorated and broken.

The consulting engineers for the airport should evaluate these pavement areas and develop plans to correct these pavement conditions.

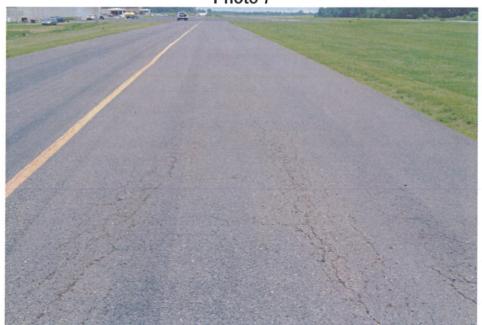
Photo 7

Area of alligator cracking in taxiway to Runway 2

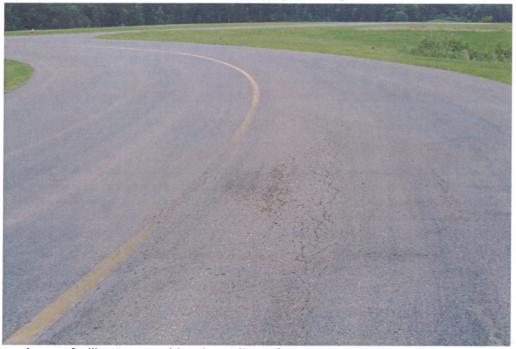
Area of alligator cracking in radius of curve in taxiway to Runway 2

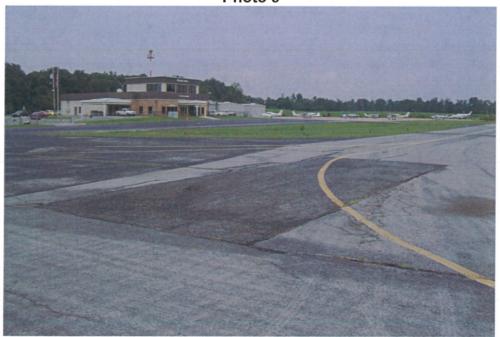
Photo 9

Area of failed pavement at taxiway and ramp intersection

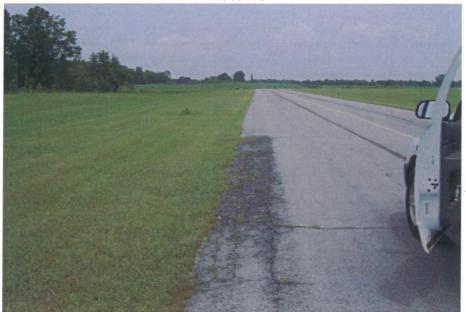
Area of pavement damage on taxiway to Runway 20

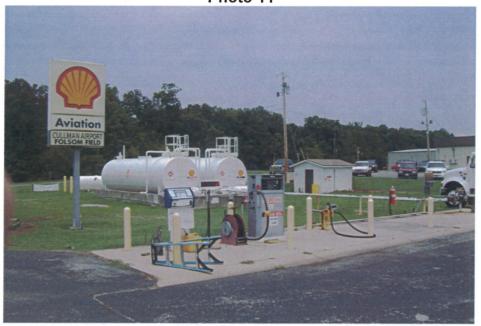
→ The fueling area meets the requirements established by the Alabama Department of Transportation. However, the State of Alabama Department of Agriculture and Industries may have additional requirements for fueling systems that were not considered during this inspection.

Fueling Area
